CITY OF MOUNTLAKE TERRACE

TOWN CENTER PLANNING PROJECT

Synthesis of Past Reports and Assessments Concerning the Civic Center Building

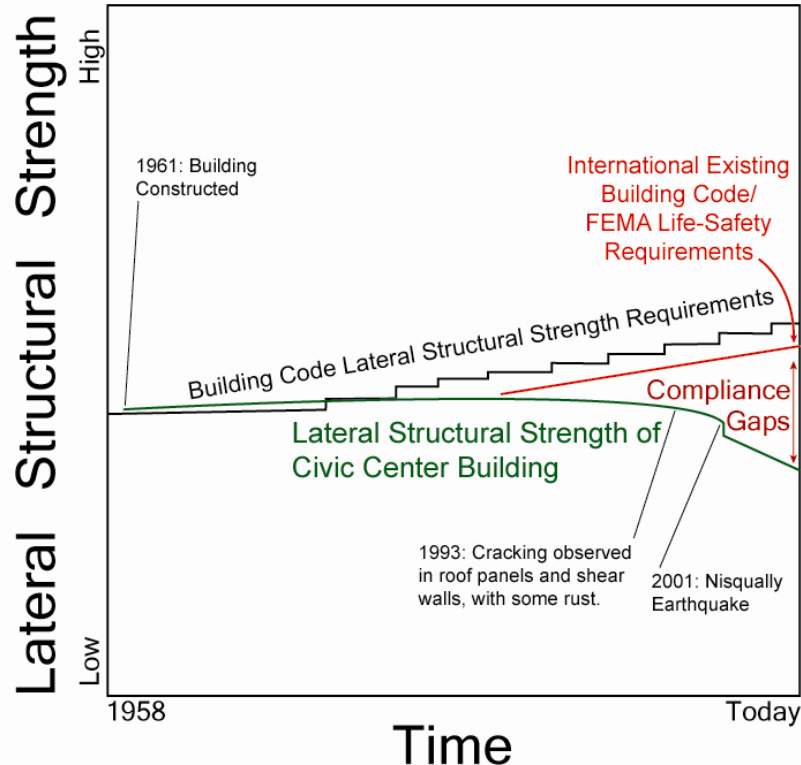
Exhibit 9 Building Strength and Building Code

Exhibit 9 illustrates, in general terms, the concepts of advances in building code requirements, and the loss of building strength over time due to cracking and rusting. The stair-stepped **black line** labeled “Building Code Lateral Structural Strength Requirements” illustrates how the three-year cycle of amendments to the Uniform Building Code have led to more robust standards since the Civic Center building was designed and constructed. The **red line** that parallels the black line represents the Federal Emergency Management Agency’s standards intended to ensure that a structure will remain standing during an earthquake long enough to safely evacuate the occupants. The standards are not as robust as the Uniform Building Code, which are intended to keep a building habitable during and after shaking of a specified intensity. The **green line** illustrates how the Civic Center building was designed and constructed to meet the 1958 Uniform Building Code, become slightly stronger early on as its masonry and concrete aged, and then has become weaker as clogged drains led to standing water on the roof panels, which seeped into the concrete and caused the steel mesh to rust. Design problems with the collection and distribution of lateral forces have also led to cracking of structural elements. Following the Nisqually earthquake it is assumed that deterioration increased due to further cracking and water intrusion, and continued problems with distributing lateral forces. The **gap** between the building’s strength and the strength required by building codes grows over time.
